Title: Laser eyewear protection inadvertently not used

Date: February 27, 2013

Identifier: ORPS SC--SSO-SU-SLAC-2012-0008

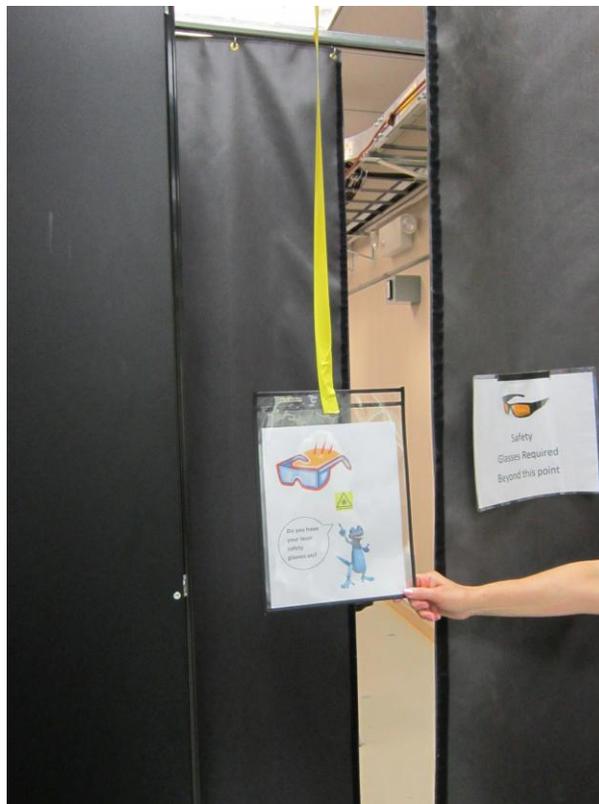
2. Root cause of the incident was:
 - Inadequate controls/barriers. Controls to ensure donning of LEP were inadequate at the entry to the Nominal Hazard Zone.

1. An additional warning sign/barrier was added at the entry to the NHZ through the laser curtain chicane.
