Achieving Success in the Commissioning and Startup of Capital Projects: Mini-Case Studies

Implementation Resource 312-2

Volume II

Case Study A

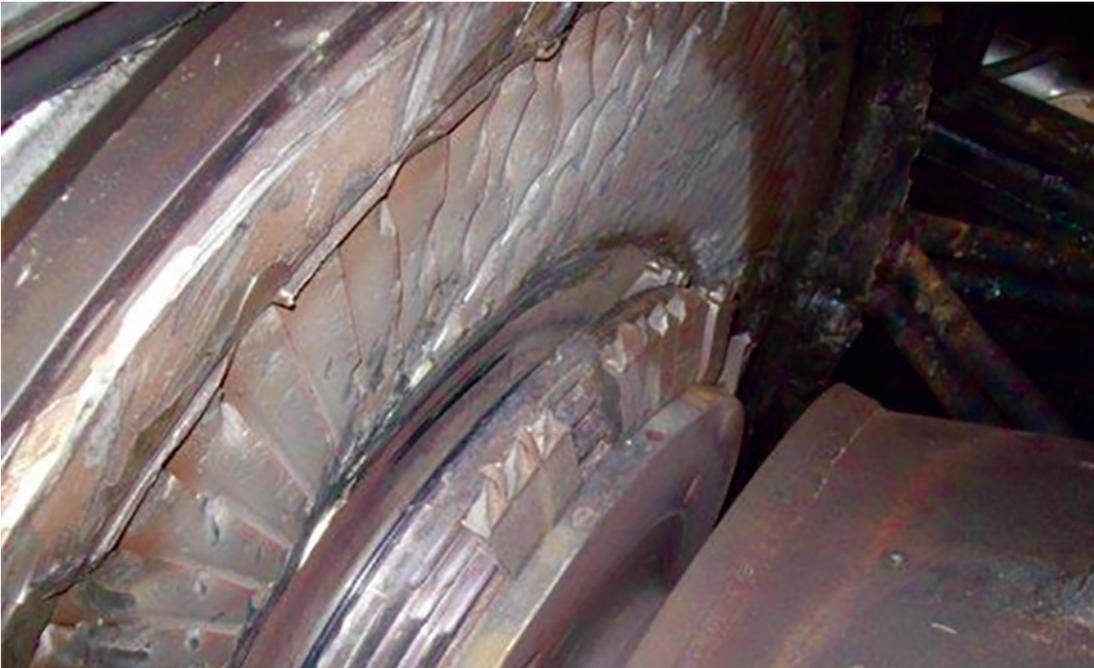
feed pump turbine accelerated past its design speed of 5,600 RPMs, resulting in failure. Then, the last stage blading of the boiler feed pump turbine was ejected through the casing, damaging nearby piping and electrical cable trays. (Figures 1 and 2 show some of the damage.) Finally, a fire erupted at the high-pressure end of the boiler feed pump turbine, as the shaft grounding device broke and discharged oil onto nearby hot steam valves. The fire was extinguished by the plant's deluge fire protection system and the water that had been released as a result of collateral damage to the boiler feed pump suction line; this line emptied the entire deaerating heater storage tank contents (approximately 60,000 gallons of 300°F water) onto the failed boiler feed pump turbine. The plant was evacuated, all personnel were accounted for, and the unit was removed from service for repairs. After the event was contained, two major questions remained: 1) What caused the uncontrolled acceleration?; and 2) Why did the boiler feed pump turbine fail to trip?

Figure 1. Last stage blading roots and diaphragm (a stationary component that directs steam into the last-stage blading).

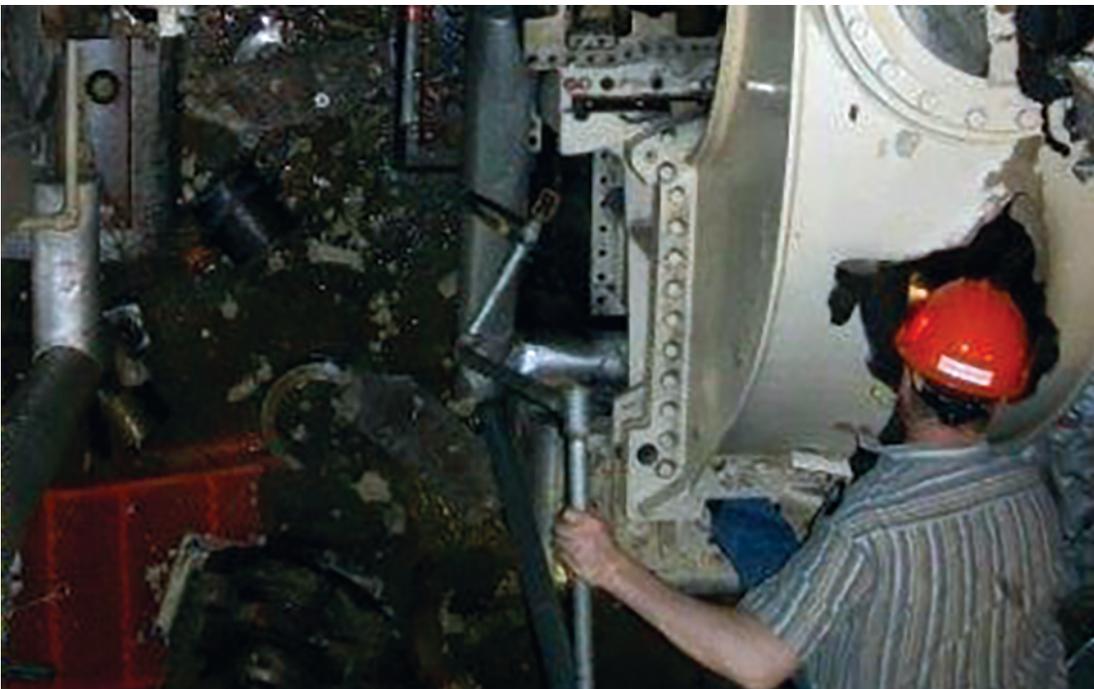
Figure 2. Wreckage on the exhaust hood and low-pressure end bearing
