Accident Investigation Board (AIB) *for the Test Site 9920 Event*

SAND2014-2192 P

Accident Investigation into Explosion Injury at Sandia National
Laboratory, December 11, 2013

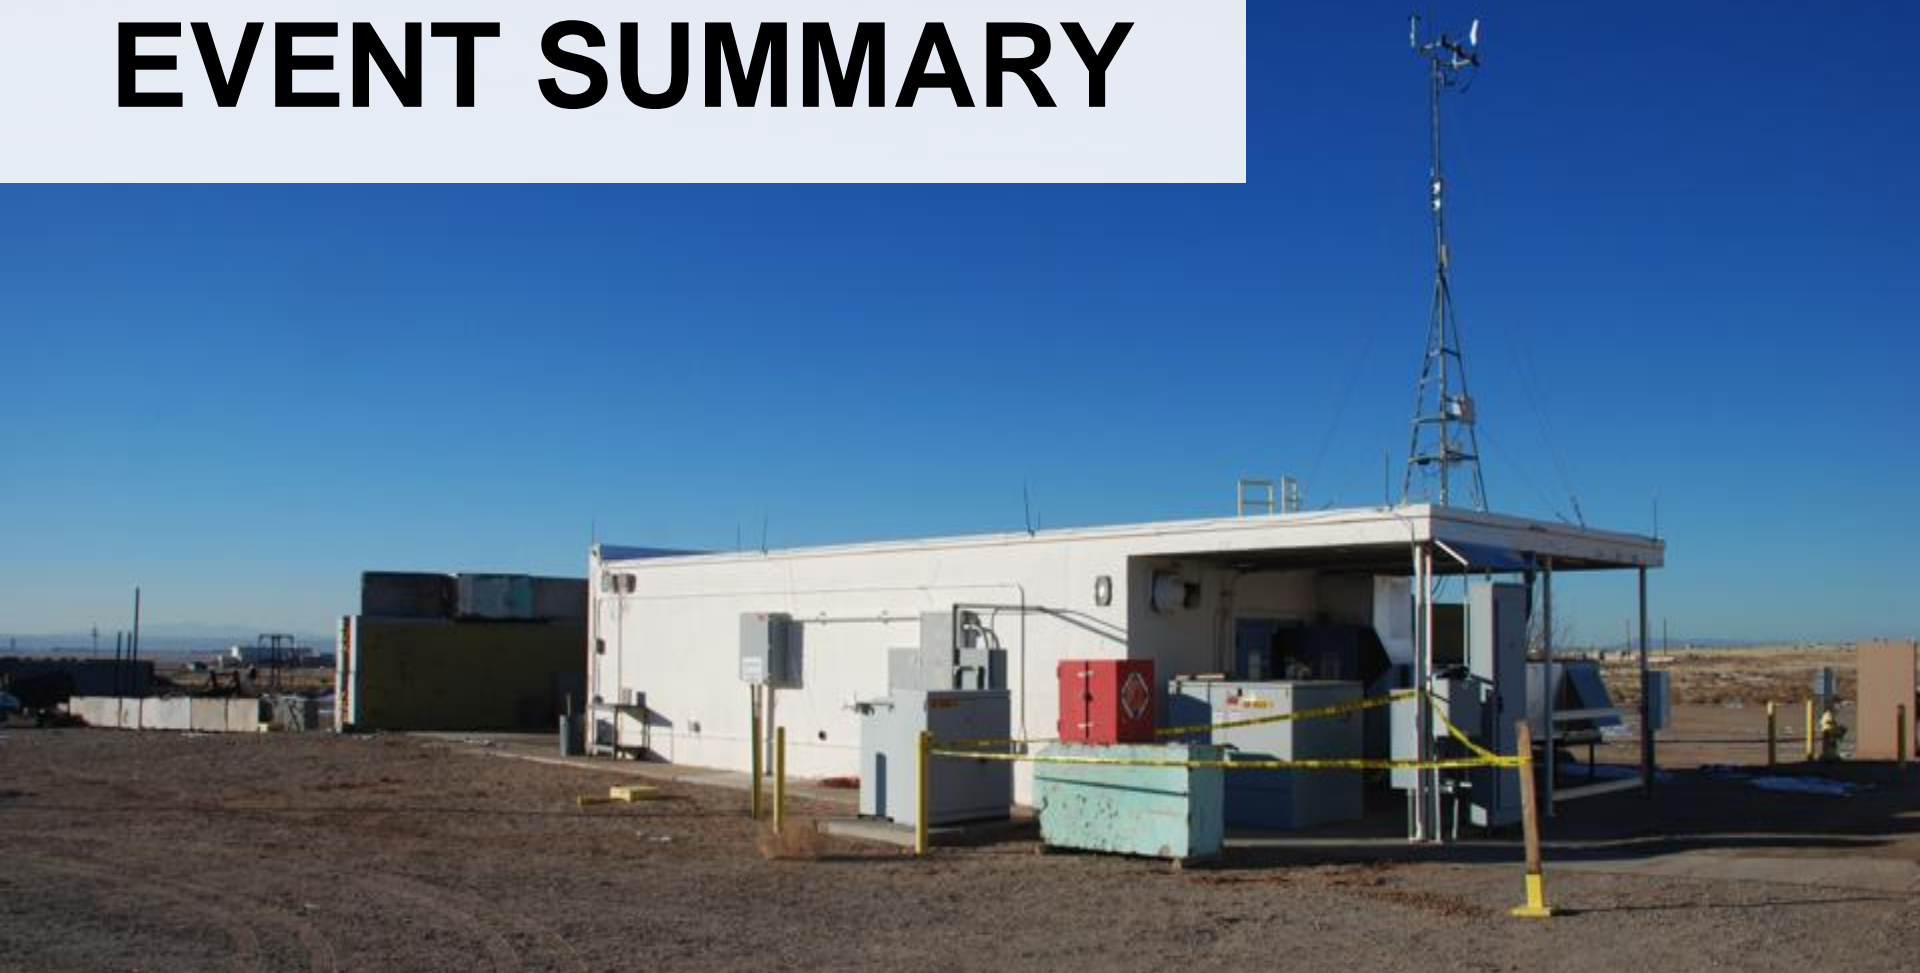
EVENT SUMMARY

During an explosives test at Site 9920, an individual received an injury to their left hand when the detonator in the test unit fired during troubleshooting.

The direct cause of this accident was a failure in the test device, from mechanical disturbance or electrostatic discharge, which caused an unexpected detonation.
