Fall 2005 Photos GE Performaing Major Inspection of ANO Unit 1 Westinghouse HP and Generator

Spring 2013 Photos Siemens / Bigge Removing ANO U1 Stator (for replacement)

NOTIFICATION OF UNUSUAL EVENT DECLARED DUE TO A BREAKER EXPLOSION IN THE PROTECTED AREA

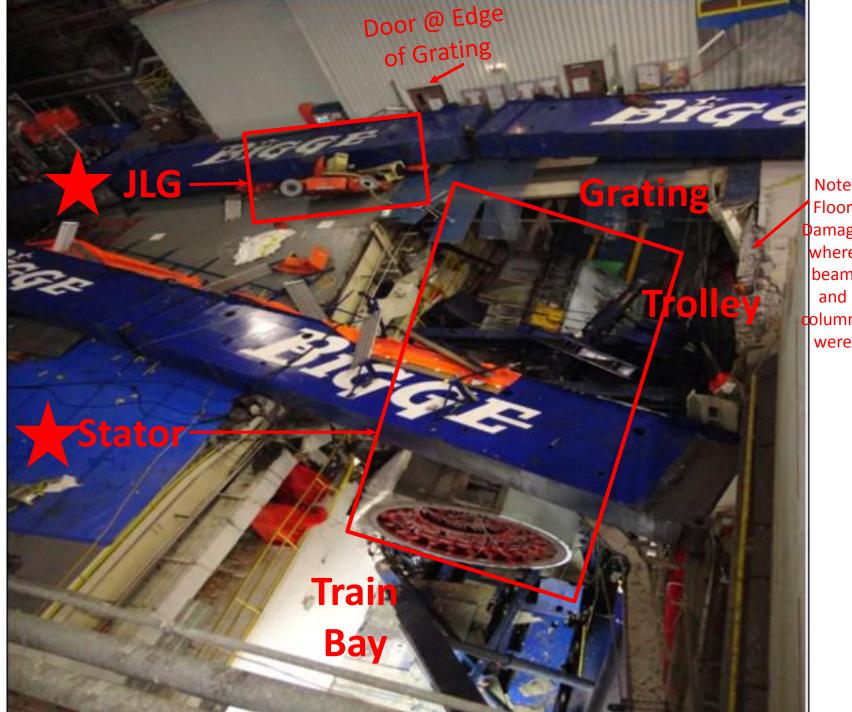
Note Floor Damage where beam columns were

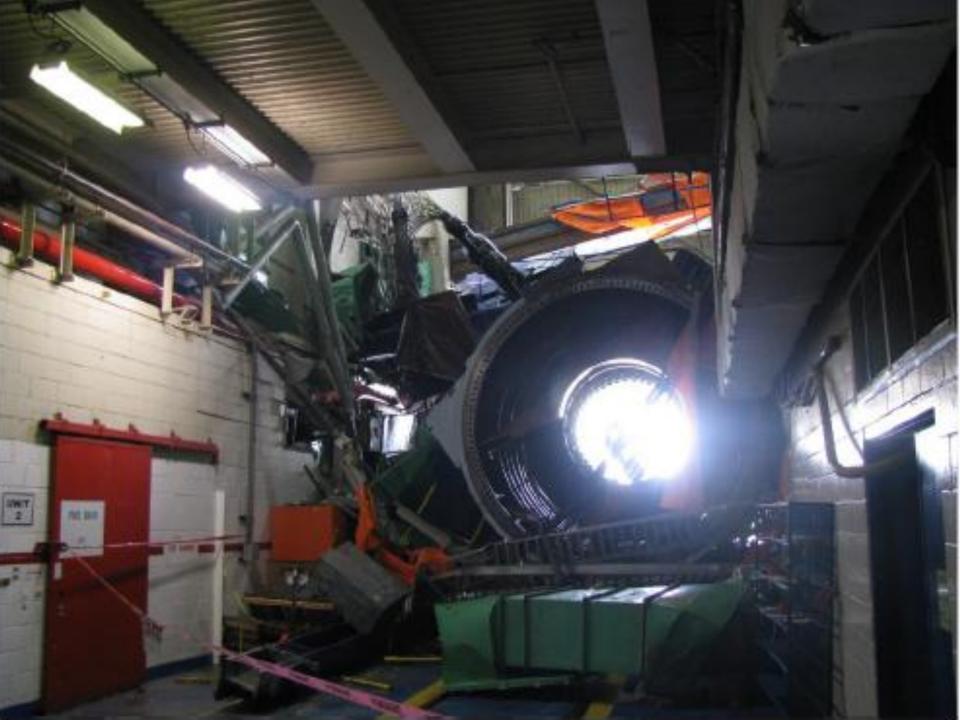
Stator Stator Rolled CCW

Stator

(On side)

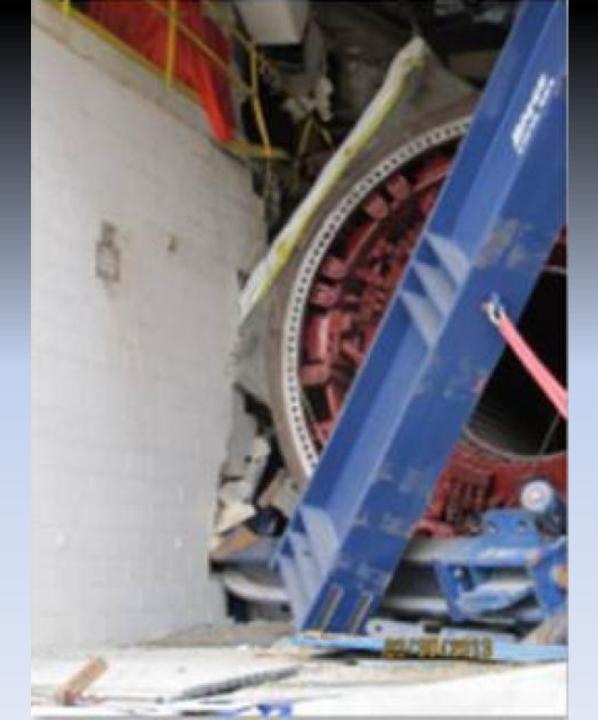
Note possible ruptured fire water pipe/water spray just after event

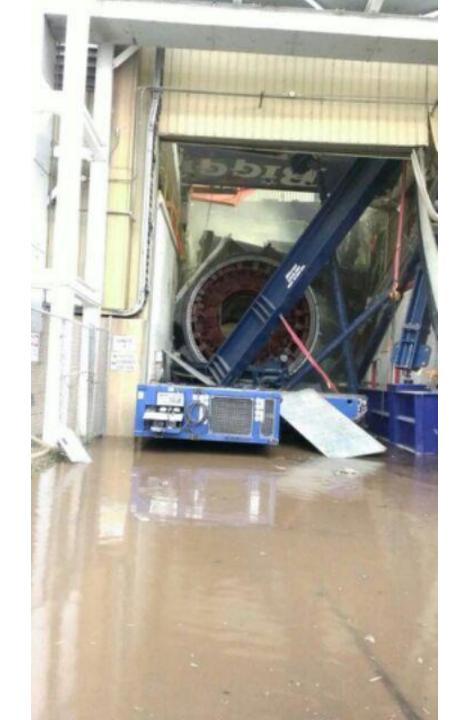
Note water

Note water has subsided
