Priest Rapids P08 GCB Incident Root Cause Analysis Results

Ty Ehrman

Senior Manager, Power Production Engineering

July 24, 2017

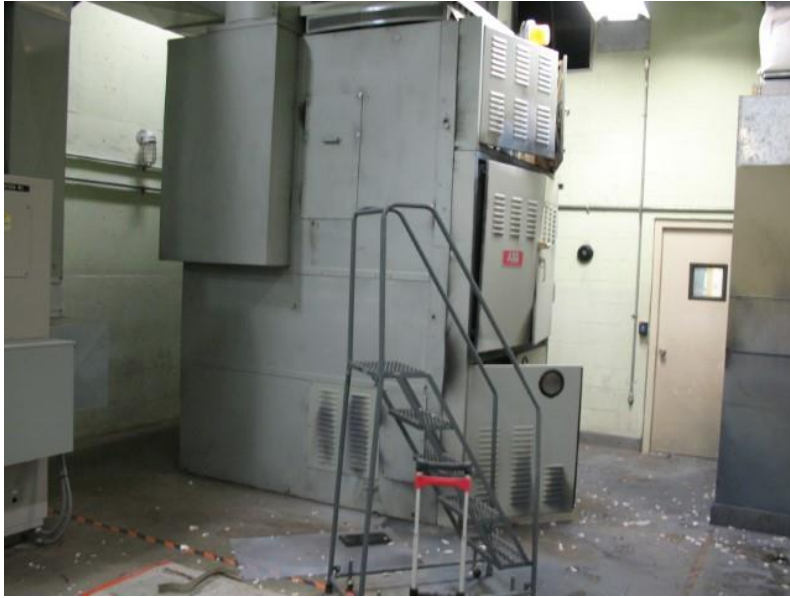
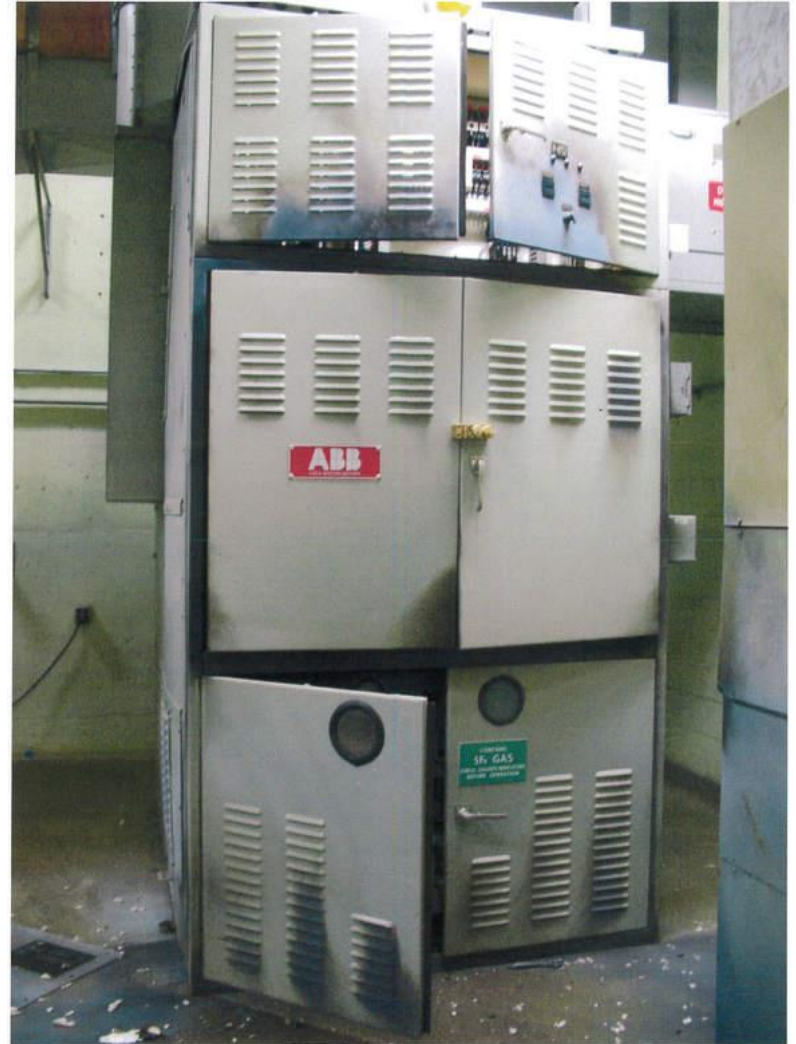
Generator Breaker Cubicle

This caused severe arcing and overpressure within the GCB which resulted in the explosion.

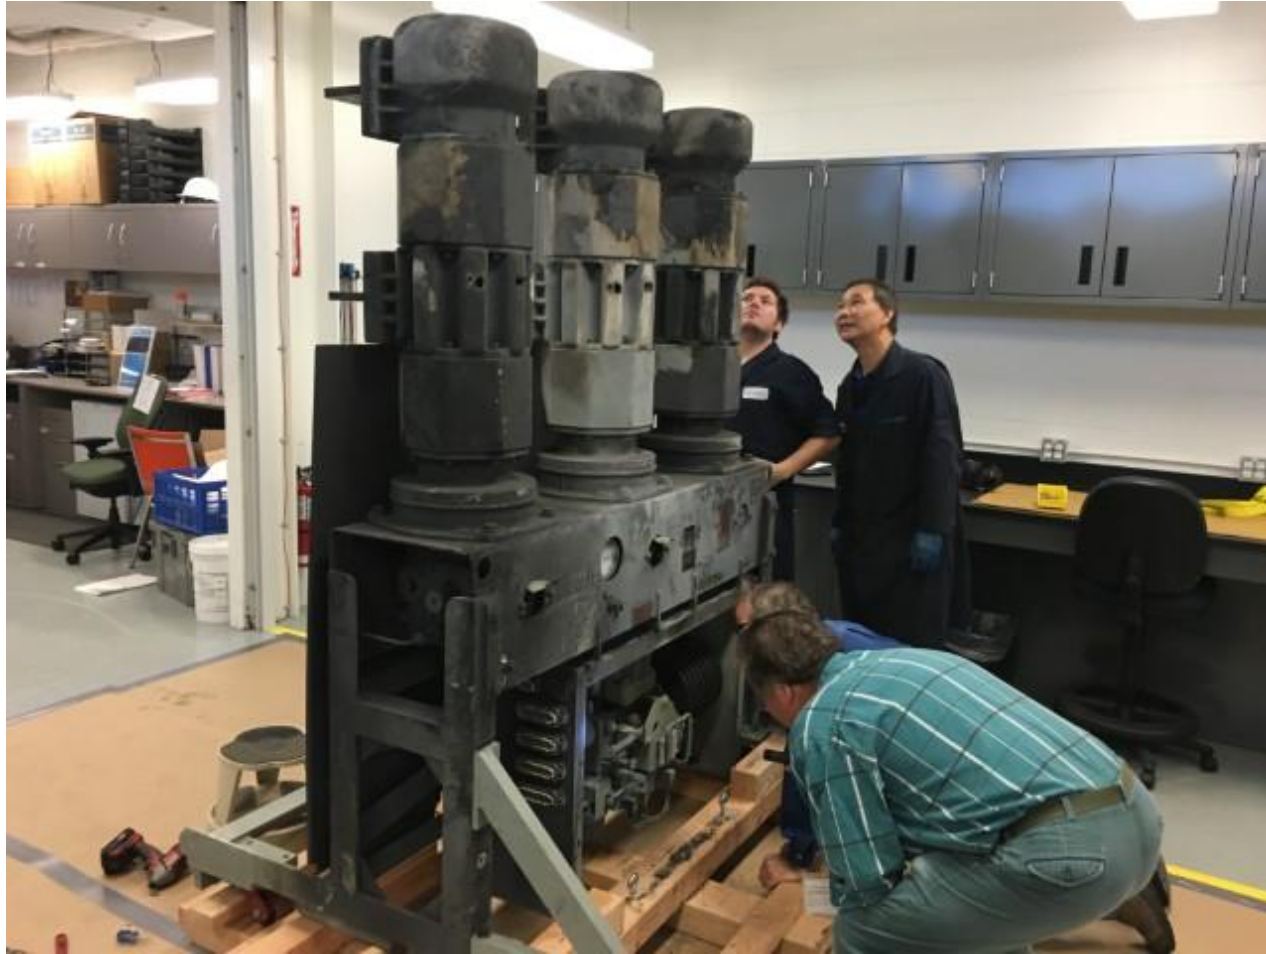
Forensic Analysis Underway

- Powertech Labs of Surrey, British Columbia, Canada completed forensic investigation on the GCB
- The forensic results:
 - The GCB functioned as designed
 - No issues of performance due to age or maintenance
- GCB closure 15 minutes after the incident
 - No conclusive evidence for the closure has been identified at this time
 - Theorized that due to the heat and stress of the explosion that after 15 minutes, the metals within the GCB cooled causing the closure (release).

In short – breaker performance did not cause this incident.
