#### Volume 4 Issue 3

# Laser Lessons News Letter

Lessons Learned P.1 Take Care When Selecting Laser Eyewear P.1 Wear Your Laser Eyewear! P.2 Safety Gate Valve Improperly Locked Out/Tagged Out P.3 Use of Incorrect Eyewear Leads to Laser Eye Exposure P.4 Laser Strike Startles Worker P.4

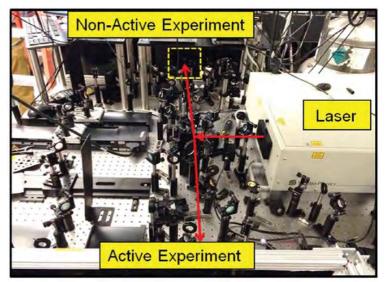
Figure 2. Laser showing two beam paths

On November 19, 2015, a laser worker received an eye injury at a DOE Lab from a reflected, non-visible laser beam. The laser (Class 4, pulsed, wavelength 800 nm) was configured to split the beam into two work areas in which qualified operators conduct research experiments. During this incident, the laser output was being projected to both experimental work areas, although only one experimental area was actively being used (See Figure 2). The laser beam directed to the second work area was blocked by an optically opaque material. (See Figure 3)

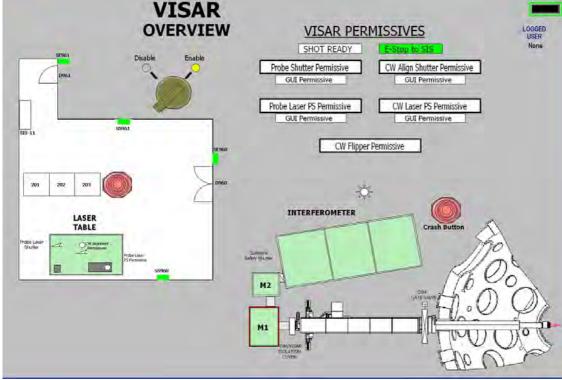
Figure 5. Graphical User Interface showing laser beam path locations and permissives

A manual gate valve (Guillotine Safety Shutter) was found to be improperly Locked Out/Tagged Out (LOTO) in the open position at a DOE Lab. This valve is used to block laser light. A worker mistakenly applied the lock in the "open" position prior to performing work. Upon discovery, work was paused and the LOTO was correctly applied.

The configuration of this laser system is such that the energizing of lasers and opening of shutters are permissivebased from a separate control room via a Graphical User Interface (GUI). (See figure 5)

A permissive was requested and given for laser operations (laser was on), but not to open shutters on the optical table (shutters closed). If a permissive was given to open "Probe Laser Shutter" the laser light would be allowed to transmitted past the probe shutter to the Interferometer Table, via fiber optics and through the system past the open guillotine safety shutter.

- There was not a policy that defined when the use of an Energy Isolation Procedure is required.
- Workers did not recall their LOTO training.
- The indicator slide at the LOTO point was not clearly visible and identifiable due to a black background and limited lighting environment.

the control room and logged. When using LOTO to isolate any high energy source, ensure that procedures are followed, and the isolation point truly insulates the hazard and BE SAFE!
