# SMC Laser Injury Event

Level 1 Cause Analysis in Support of

ORPS-ID--BEA-SMC-2011-0012  
NTS-ID--BEA-SMC-2011-0004

INL/INT-11-23268

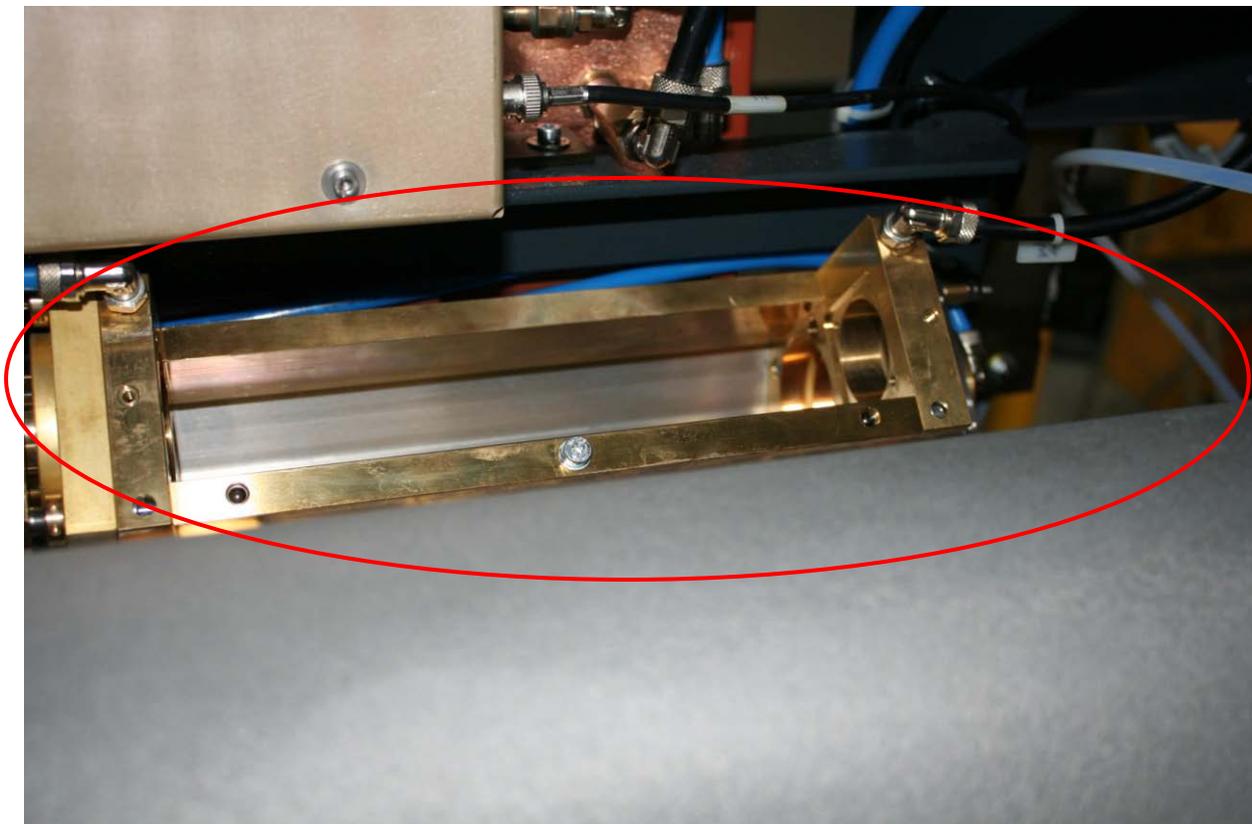
Figure 3. Z Box.

- 1050 Technician #1 reaches to place the target at the end of the Z box and a “Flash” occurred which they all saw. The technician immediately retracts his hand with the target.
