# EFCOG Best Practice #100

**Best Practice Title:** Open Air Demolition of Asbestos Gunitite by Using Track Mounted Wet Cutting Saw

Facility: Lawrence Livermore National Laboratory (LLNL) B328 Demolition

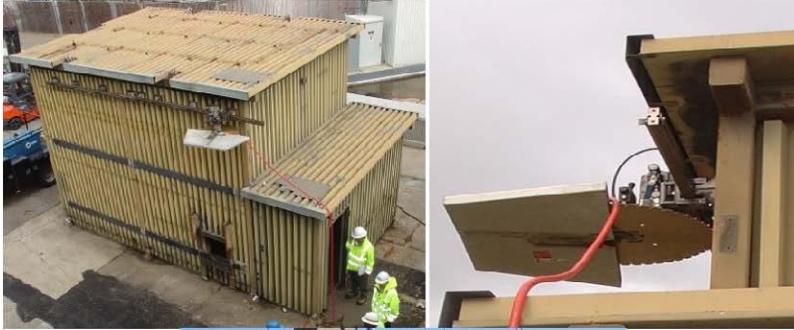
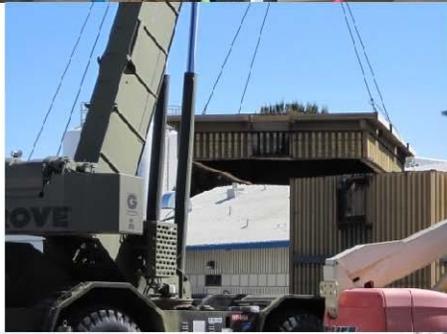
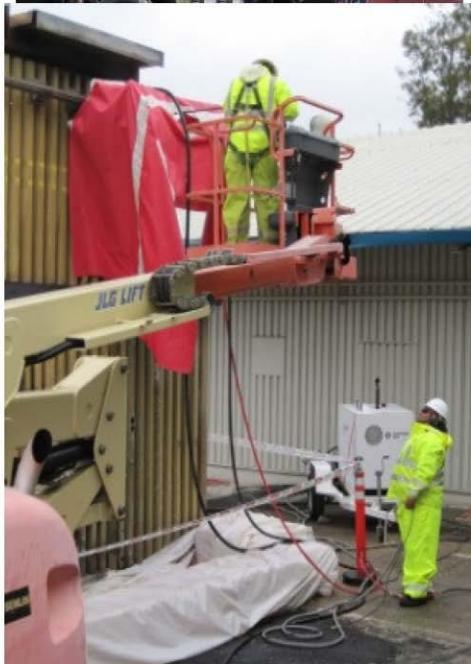
Videos Pictures:

Before dismantlement, sampling of firebrick on a burn-building at LLNL led to the discovery of 8% friable asbestos sandwiched material. The outer skin of the structure was made of metal and corrugated metal that dissipated heat. After considering 3 different methods for dismantlement, it was determined that the best option was to cut the building into sections using a diamond blade track mounted wet saw.

This process consisted of multiple cuts using the wet saw. First, the roof was cut off and lifted off the building using a crane. Once the roof was at ground level it was cut into smaller sections. When the wet saw became too cumbersome a hydraulic wet chainsaw was used for the final cut.

Before the removal of wall sections, the building was structurally supported by welding steel members measuring 6” x 5/8” by 8 to 10 feet onto the building. The welded steel supports restricted the building from flexing and/or crumbling thus preventing the asbestos from dispersing in the air. Rather than scabbling the walls of the building which would break-up asbestos making it disburseable into the air, the asbestos was kept sandwiched between the walls. The wet saw cutting, effectively contained the asbestos between the gunitite and metal layer. Other sections, including metal, on the building that did not contain asbestos were torch-cut.
