# HISTORY OF CAUSAL ANALYSIS - TWO AVIATION CASE STUDIES

# Investigation and Causal Analysis

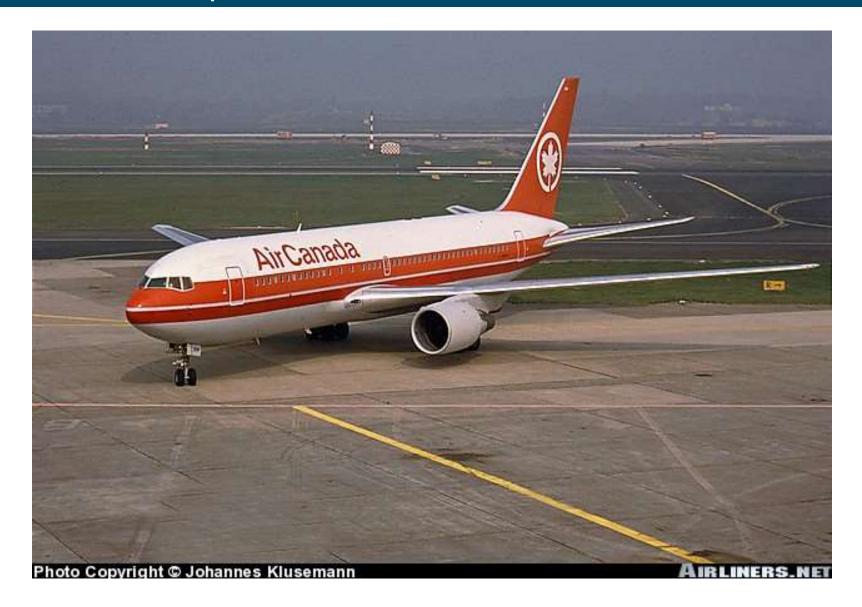
## Boeing 767

- Fuel gauges inoperable due to electronic fault known to pilots
- Both engines cease operation at 41,000 feet
- Cockpit went black lost all instruments, lights and hydraulics
- Aircraft is dark and quiet no power
- Descending at 2,500 meters per minute
- Power and hydraulic systems ran on power generated from Rapid Air Turbine - power was reduced as aircraft speed slowed
- Headed aircraft toward Winnipeg, couldn't make it
- Co-pilot had been in Royal Canadian Airforce stationed at Gimli
- Diverted to Abandoned Royal Canadian Airforce base Gimli

- Used wrong conversion factor when fueling.
- First plane to feature kilograms and liters.
- Ground crews and pilots not trained in metric conversion
- First air crew of only two people pilot and co-pilot. All other flights had flight engineer who usually did fuel calculation.
- Digital processors to calculate fuel not working so fuel gauges not working. Tagged out one processor, flight allowed, but dip tests required.

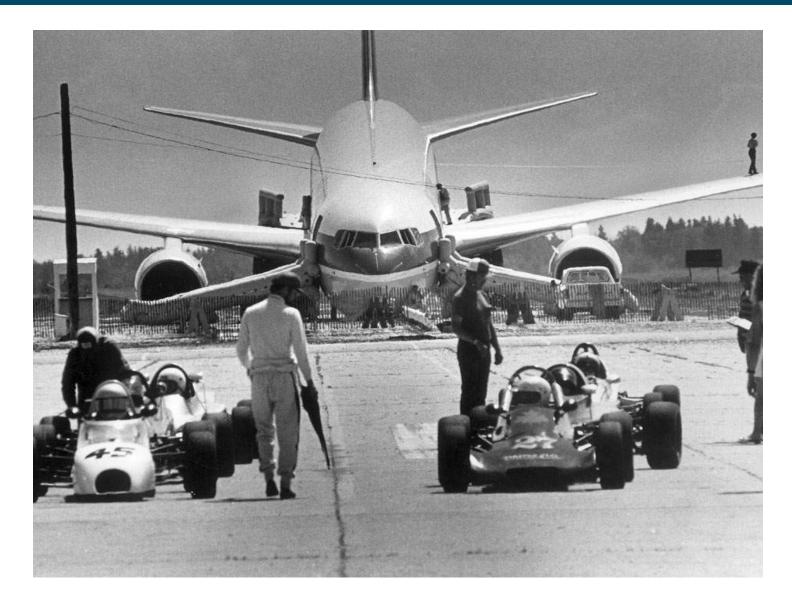
#### On the Ground

- Nothing in the procedures on how to land with no engines or power
- Approaching Gimli, they are going to fast
- Captain Pearson had been a glider pilot and decides to "slip" the aircraft to reduce speed
- Front landing gear doesn't lock in First Officer decides not to tell Captain as it's too late, and he has enough on his mind
- Gimli has been turned into a raceway and the runway is a dragstrip with cars and day camping all along the runway
- Kids riding bike on the runway
- Barrier in middle of runway
