This issue

Introduction

Accidents

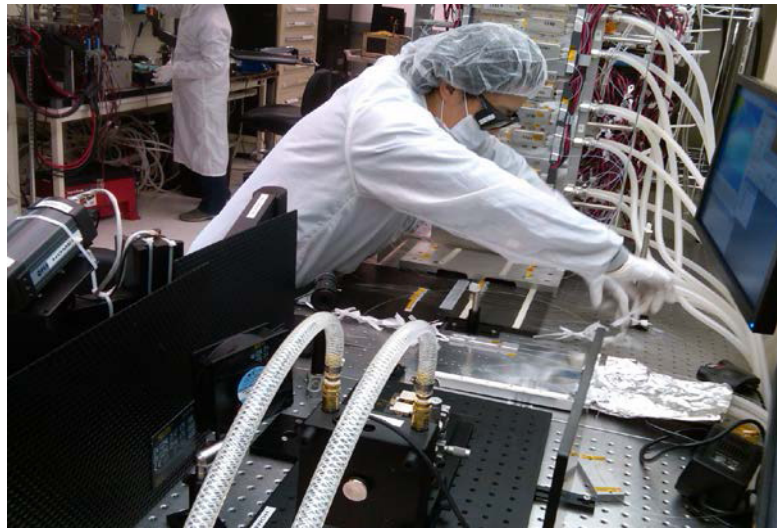
Figure 2. Worker position

In order to perform this task, the worker was required to lean over the test rig (Figure 2). Much of the operation safety relied on Administrative Controls. With that, human factors took over. The worker determined that it was simply easier to make adjustments to the fiber coil with the laser left on.

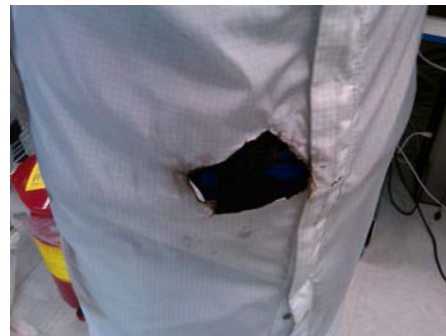
Figure 3. Melted smock

During the action, more laser radiation escaped out of the coiled fiber as the bend ratio increased. The worker’s smock came in contact with the fibers during the process and

immediately melted, igniting the worker’s sweater (Figure 3).

1. A hazard analysis was not performed.
2. The worker did not follow the procedure to turn off the laser prior to making adjustments to the fiber bend ratio.
3. The photodiode interlock was not connected during the experiment. The worker did not receive the Laser Safety Officer’s approval to operate in this manner.
4. The set up required the worker to lean over the fibers to make adjustments.
5. No barrier was placed in front of the fiber coil.
6. The worker was new to the area and new to R&D type work.
7. The worker was only familiar

with low power lasers through fiber optics and did not receive an introduction to this operation prior to commencing work activities. 8. The worker did not use the test operation checklist and could not produce a Standard Operating Procedure.

In situations where the Optical Density (OD) requirements are greater than OD7, it is much better to enclose the beam or to remove yourself from the area and operate the laser remotely. PPE will provide your eyes protection for a brief period while the laser is burning through the filter-media. Your skin though is generally not protected. This is true even if you are wearing tightly woven clothing, as in this accident.

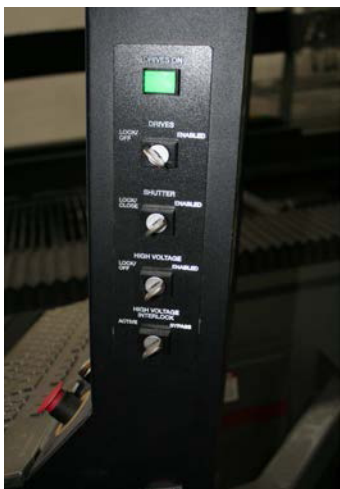
Figure 4. Laser pendant

selected the “Mirror Alignment” program from the human machine interface (HMI) screen. They enabled the pendent and pressed the “Cycle Start” button (Figure 4). The technicians believed that the laser was in “simmer” mode at this point and that no beam was being generated out of the resonator (Figure 5). A beam was
