This issue:

Lessons Learned

Is the other end of your fiber live?

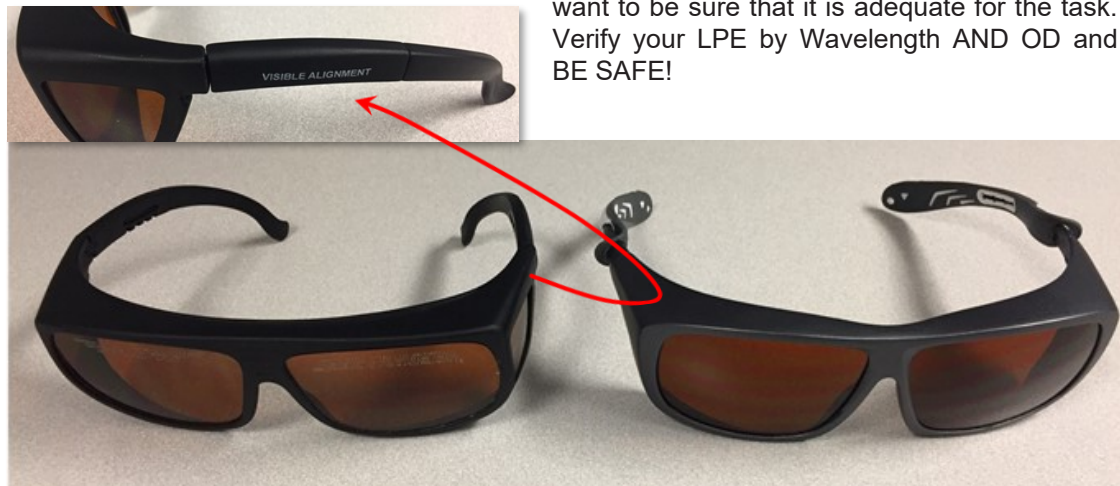
On April 3, 2017, a pair of alignment laser protective eyewear (LPE) was found comingled with those specified for the designated work. The eyewear was clearly marked with “Visible Alignment” (See Figure 2).

They were called to the attention of the LSO after being discovered in a pre-job inspection. The specific filtering requirements for this procedure were to provide protection against 1053nm, 808nm, and 527nm. This eyewear provided protection at a reduced level (alignment) for the 527nm (green light). It is assumed that

Figure 2. LPE on left, designated “Visible Alignment” found with full protection eyewear

the LPE was brought into this area because it appeared visually similar to that of the correct eyewear.

- Alignment eyewear is stored separately from regular protection LPE. Somebody found them, did not read the OD/wavelength, and brought them to the "community bin" for this LCA. The shortcut was relying on the color of the filter alone. This is a big NO-NO!

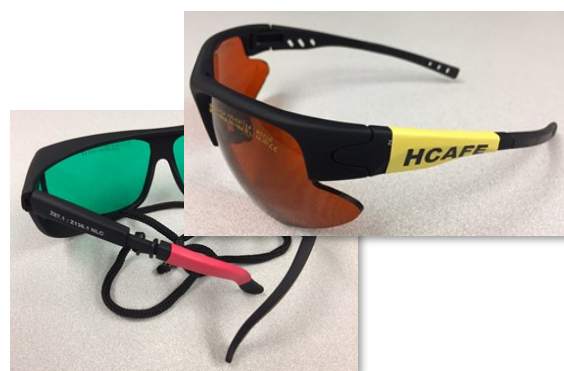
Figure 3. Specially marked eyewear

This LCA now requires that specially marked eyewear be used. Alignment eyewear has a red band and full protection a yellow one (See Figure 3). LPE is your last line of defense. It is very important that you never select them based on the filter color. There are many formulations of filters available for the same wavelengths that will NOT provide you satisfactory protection. Prior to using any type of PPE, you want to be sure that it is adequate for the task. Verify your LPE by Wavelength AND OD and BE SAFE!
