Accident Investigation Board (AIB) *for the Test Site 9920 Event*

SAND2014-2192 P

Accident Investigation into Explosion Injury at Sandia National
Laboratory, December 11, 2013

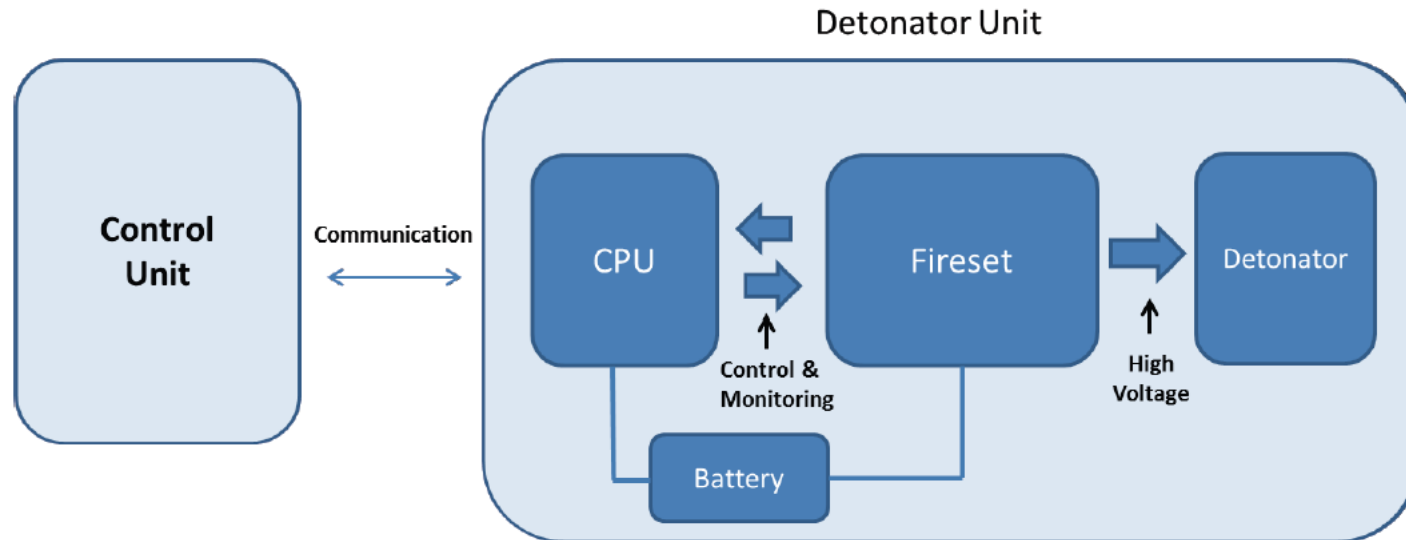
TECHNICAL ADVISORY TEAM (TAT)

Conducted scientific and engineering analysis and provided technical expertise

- Review and understand the design
- Determine potential failure paths

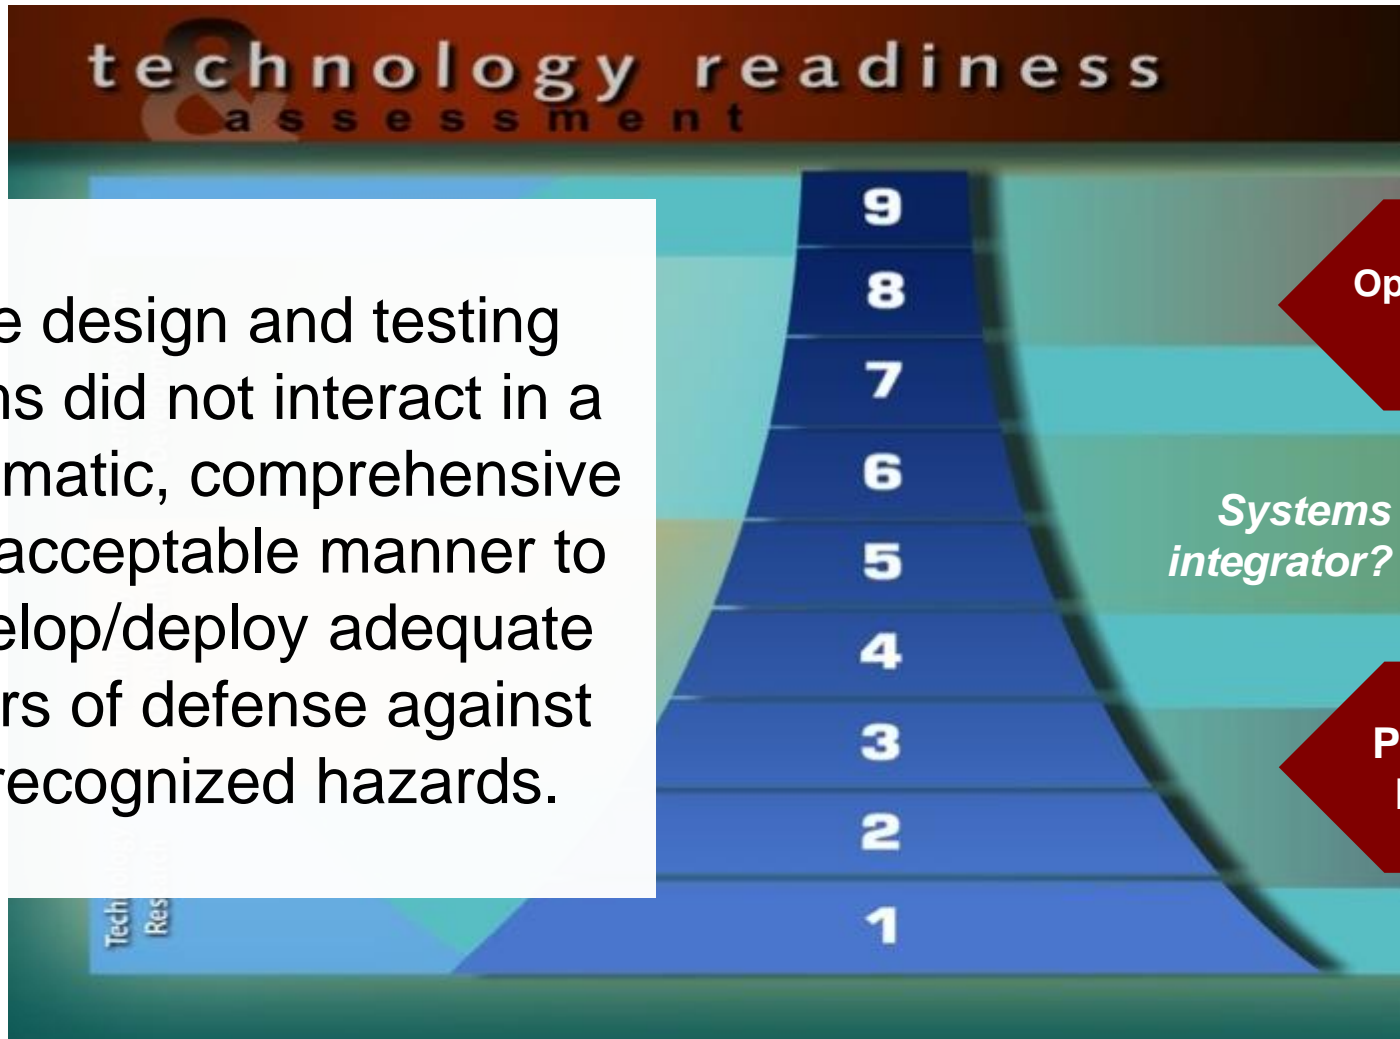
3: LACK OF INTEGRATION AND UNDERSTANDING OF THE PROJECT

The design and testing teams did not interact in a systematic, comprehensive and acceptable manner to develop/deploy adequate layers of defense against unrecognized hazards.

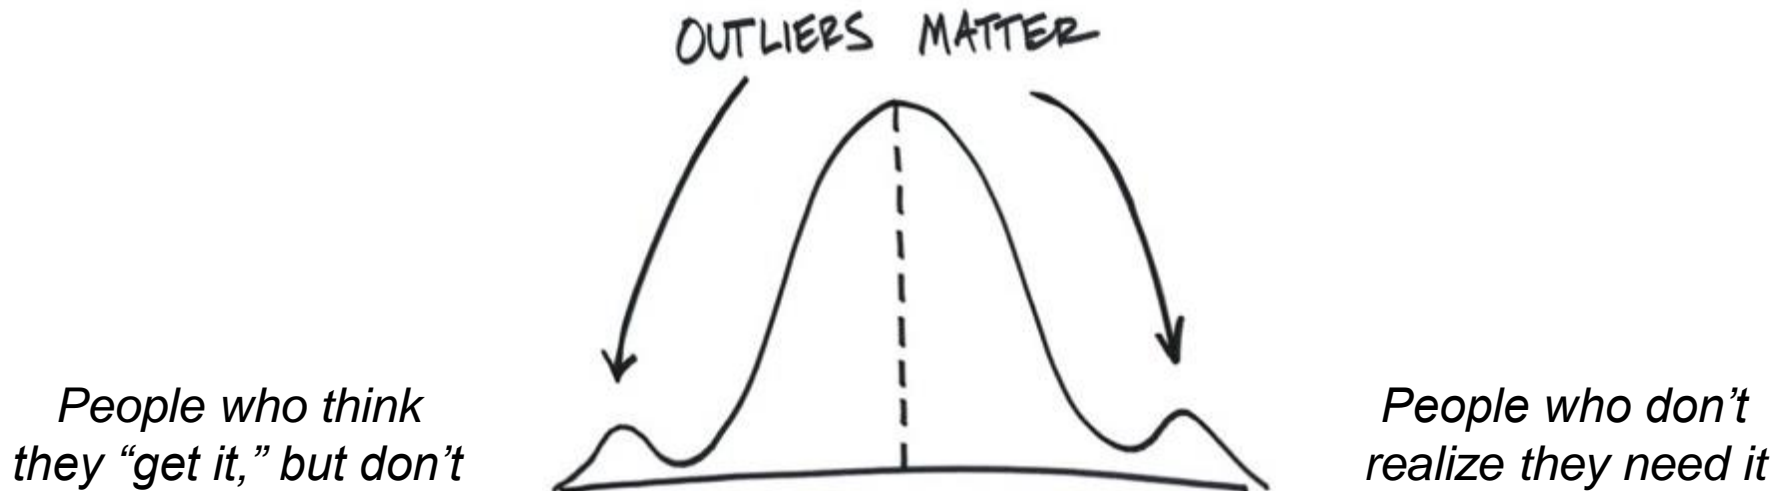
4: DIFFERING SAFETY CULTURE MATURITY LEVELS

Sandia's diverse workforce has varying levels of safety practice maturity. Typical approaches to advancing the maturity of safety culture have not been sufficiently tailored to reach all individuals in the workforce, according to their individual needs.
