May 8th, 2013

USER ADVISORY NOTICE**3M™ Lens Assembly 6898****Includes Full Facepieces 6700, 6800 and 6900 and 3M™ Powerflow™ PAPR****(See Appendix A for complete list of products)**

3M™ Lens Assembly 6898 User Advisory Notice
 List of Product Configurations Included in User Advisory Notice

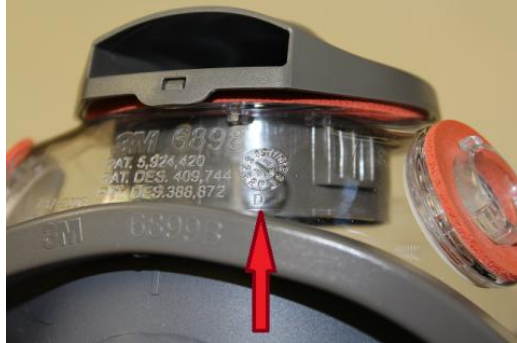
- 1.) Toward the bottom of the lens, a letter is stamped next to a small date wheel. (See Figure 1.) If this letter is an A, B, or C, your facepiece is not affected. You can continue to use it as it is. **If this letter is a D or E, proceed to step 2.**

Figure 1. Location of date code

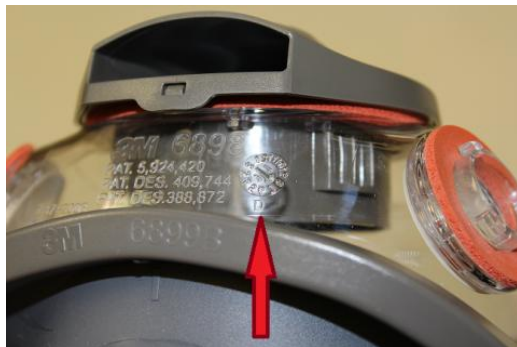
- 2.) Toward the bottom of the lens, a letter is stamped next to a small date wheel. (See Figure 2.) If this letter is an A, B, or C, your facepiece is not affected. You can continue to use it as it is. **If this letter is a D or E, proceed to step 3.**

Figure 2. Location of date code

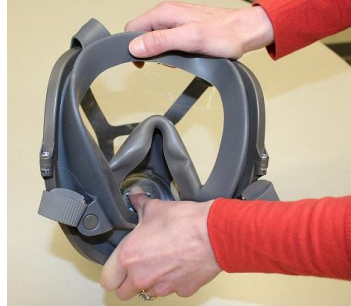
The center adapter is the rigid gray circle attached to the clear lens. Reach into the facepiece and push outward on the rigid gray center adapter. (See Figure 3.)

Figure 3. Push outward on center adapter.

If the center adapter does not move when pushed on the center or anywhere on the edge, your facepiece is not affected. You can continue to use it as is. If the center adapter can be pushed outward, so that a gap is created between the lens and the center adapter (Figures 4 and 5), then **your lens is needs to be replaced. We strongly recommend discontinuing use immediately and discarding the affected lens.** Contact 3M Customer Service for your replacement options. 3M Customer Service will ensure expedient fulfillment of your replacement request.

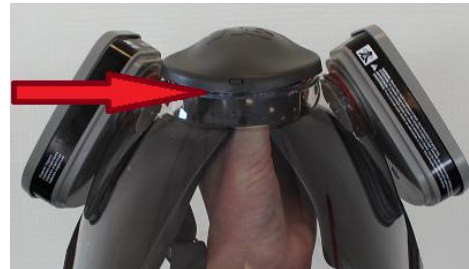
Due to a manufacturing irregularity, a limited number of lenses may not fully engage the center adapter at one of the three points of contact which could result in a separation of the center adapter from the lens if the center adapter is forcefully pushed or pulled. We believe the probability of a separation occurring during use is very low and if it did happen, it would be identified before use by a positive pressure user seal check performed as described in the User Instructions. In addition, if separation occurred for powered and supplied air configurations, airflow would be detected at the area of separation, since the facepiece is under positive pressure during use.

Figures 4 and 5. If your center adapter is moveable, the gap forms between the lens and the center adapter, at the top of the center adapter. (Shown without nose cup for clearer view.)
